KOYO INSIDE Q3 - 2020

Inside the steel industry: how bearings survive under very harsh conditions

Case study: Preventing the curious water ingress into a 4-row TRB in a steel strip rolling mill

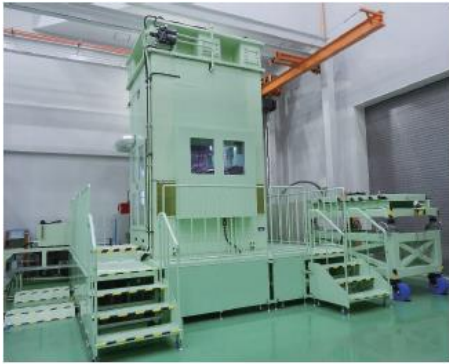
Figure 4: Bearing testing machine for steel production equipment

Japan, engineers use dedicated testing machines for bearings for steel production equipment to provide input for simulations of the most common steel production methods. With this experience potential problems can be anticipated in new steel production lines or quickly solved in existing steel mills. In some cases a complete redesign of the bearing, or one of its components is required. One such specific case is described below.
